# Manhole Inspection Summary

Manhole # S21C\_\_026MH

Insp Date: **10/16/07 1:17 PM**

**Location** Address: **522 KIRBY-FULTON**

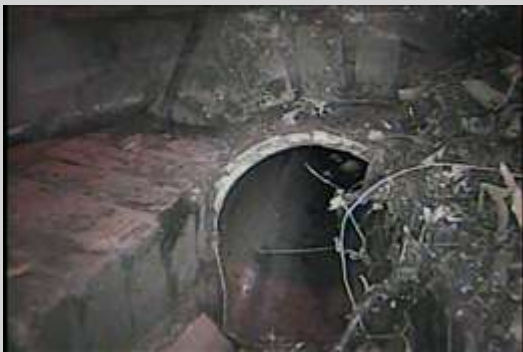
12 O'Clock Outflow

8 in. Circular Gravity Sewer  
Pipe Out @ 12 O'Clock

Pipe Height: **8.4** (in.) Rod and Bar (Angled)  
Pipe Material: **Clay** ☐ Pipe Lined  
Invert Depth: **8.83** (ft.) Flow Characteristics: **Slow**  
Deposits: ☒ None ☐ Mud ☐ Sludge ☐ **Debris** ☐ Grease  
Silt Depth: (in.) Deposits Extent:  
Infiltration: **None** Pipe Seal Cond: **Sound**

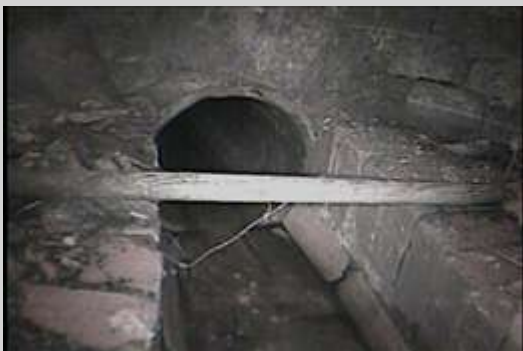
3 O'Clock Inflow

8 in. Circular Gravity Sewer  
Pipe In @ 3 O'Clock

Pipe Height: **8.4** (in.) Rod and Bar (Angled)  
Pipe Material: **Clay** ☐ Pipe Lined  
Invert Depth: **8.79** (ft.) Flow Characteristics: **Slow**  
Deposits: ☒ None ☐ Mud ☐ Sludge ☐ **Debris** ☐ Grease  
Silt Depth: (in.) Deposits Extent:  
Infiltration: **None** Pipe Seal Cond: **Sound**
